Westwood Village Homeowners Association

Waterfront Committee
Marina Condition Report
October 29, 2023

WVHA Marina

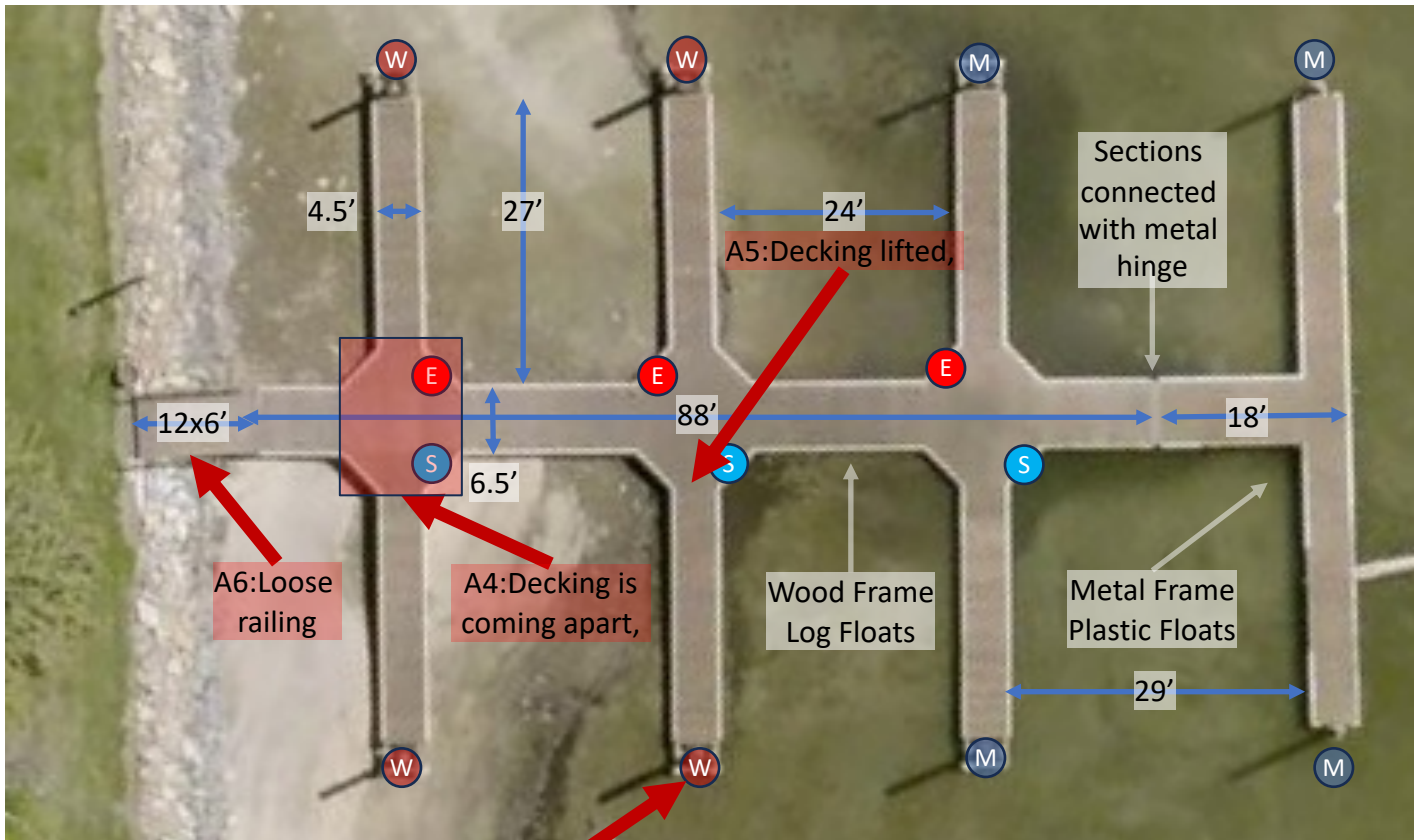
A Dock

A1: Wood piling not solid

A4: Decking is cut shorter than other similar areas, and doesn't offer the same strength over the width of the dock

A5: Decking is lifted and creates a trip hazard. The finger to dock junction appears loose

A6: One of the ramp railings is loose

A1: Wood piling is not solid

The first part of the north section (closest to shore) is slanted heavily, apparently due to one or more of the underlying log floaters losing its buoyancy. At the first intersection where the dock fingers meet the backbone the new decking was cut and installed to accommodate the uneven surface, resulting in multiple trip hazards and reduced stability. The waterline is less than 12 inches from the deck at the end of the fingers.

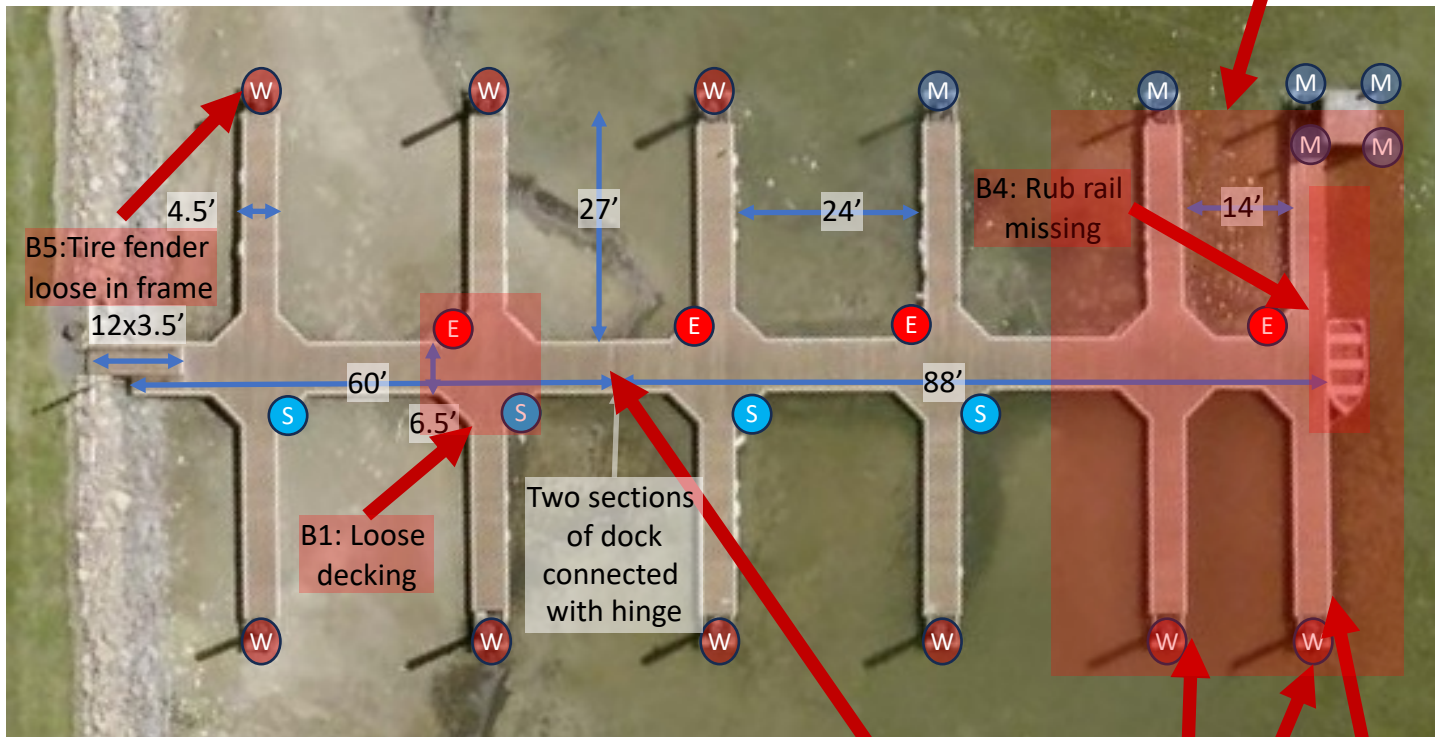
B Dock

B1: Loose decking where fingers meet dock. Frames may not be secured

B2, 3: Fingers tilted, float log buoyancy no longer adequate.

B4: Rub rail missing

B5: Tire is loose in frame

B6: Loose bolts on hinge connecting the two sections

B7: Rotted wood supports

B7: Some of the 6x6's that sit on the float logs and support the framing for the decking are rotted and crumbling.

B dock is the oldest in the marina, built in the early 1980's. It has multiple issues with waterlogged floaters and rotted 6x6 timber crossmembers on the logs that provide a base for the wooden framing and decking. The outer fingers are no longer level, indicating one of the two logs supporting them are at the end of their life.

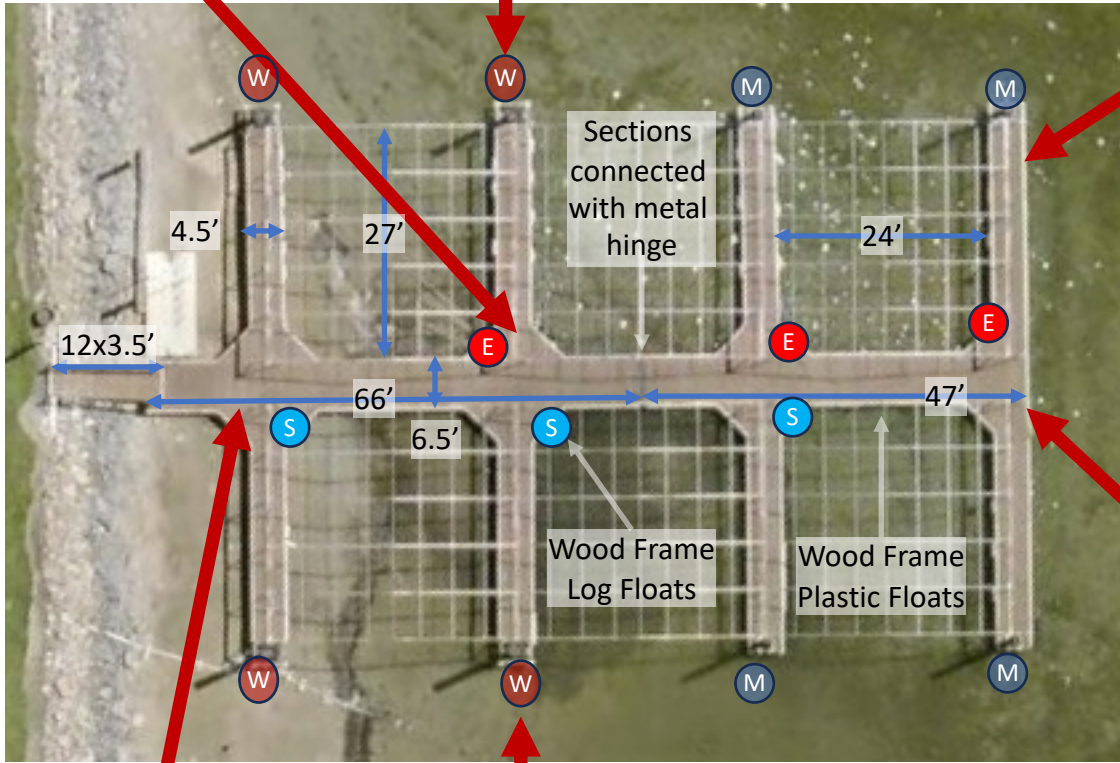
C Dock

- C1: Decking lifted
- C2: Post for the metal framework is loose from the decking. Decking is lifted.
- C3: Post for the metal framework is loose from the decking.
- C4, 5: Wood pilings are not firm
- C6: Float failure, 4x8' float under the end of the finger appears waterlogged.

The plastic float underneath the outer southeast finger on C dock has failed and appears to be waterlogged. There are structural issues with this dock as well, but it is in better shape than the other two. The metal framing for the awnings over the middle slips straddles the connection between the two dock sections and is subjected to a lot of stress as the water is drawn down and the docks settle on the ground.

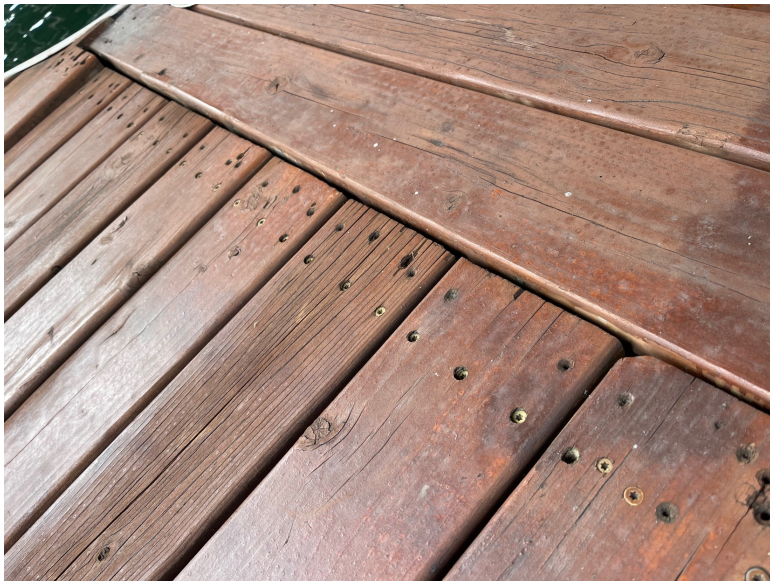
C1

C1: Decking is lifted, many screw holes. Possible rot in underlying wood frame

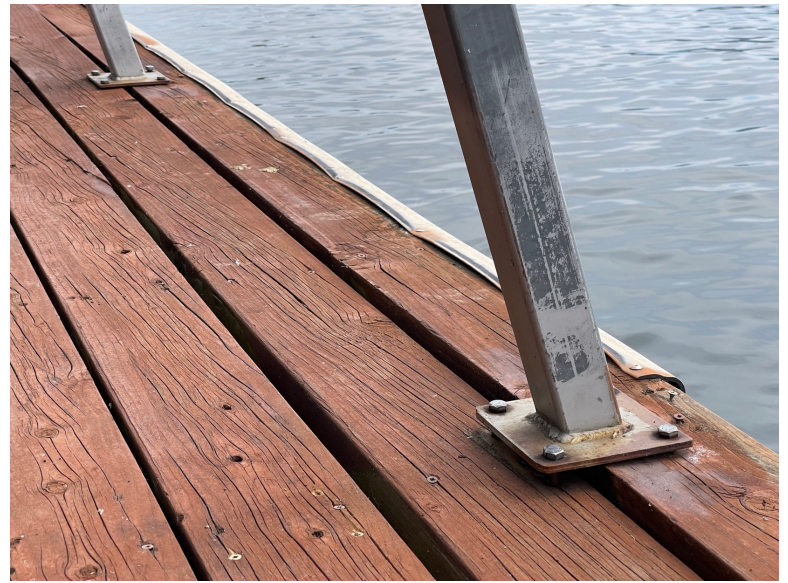
C2a

C2: Decking is lifted

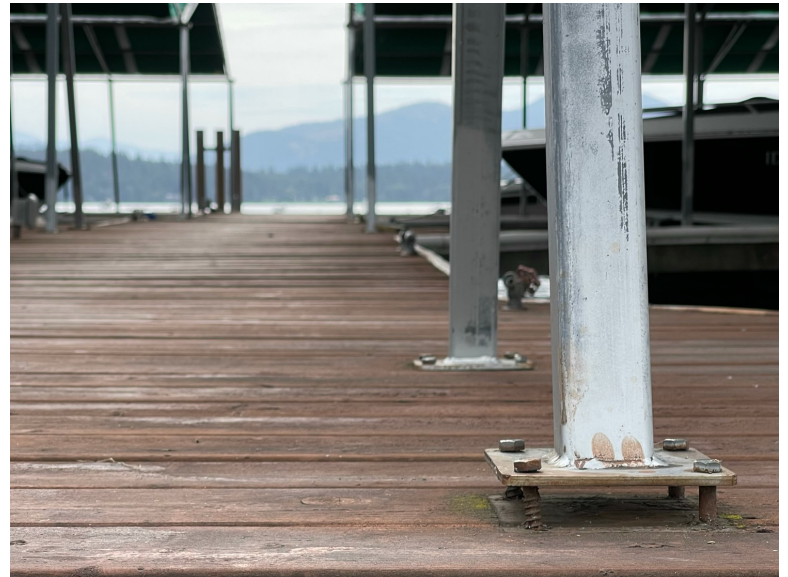
C3

C3: Base of end post for metal frame is lifted from decking
